Phase II: Chulitna River Bridge Structurally Health Monitoring

Alaska Bridge 255 – Chulitna River Bridge

J. Leroy Hulsey, Ph.D., P.E., S.E.
Professor of Civil & Environmental Engineering
University of Alaska Fairbanks
Associate Director, Alaska University Transportation Center

January 2015

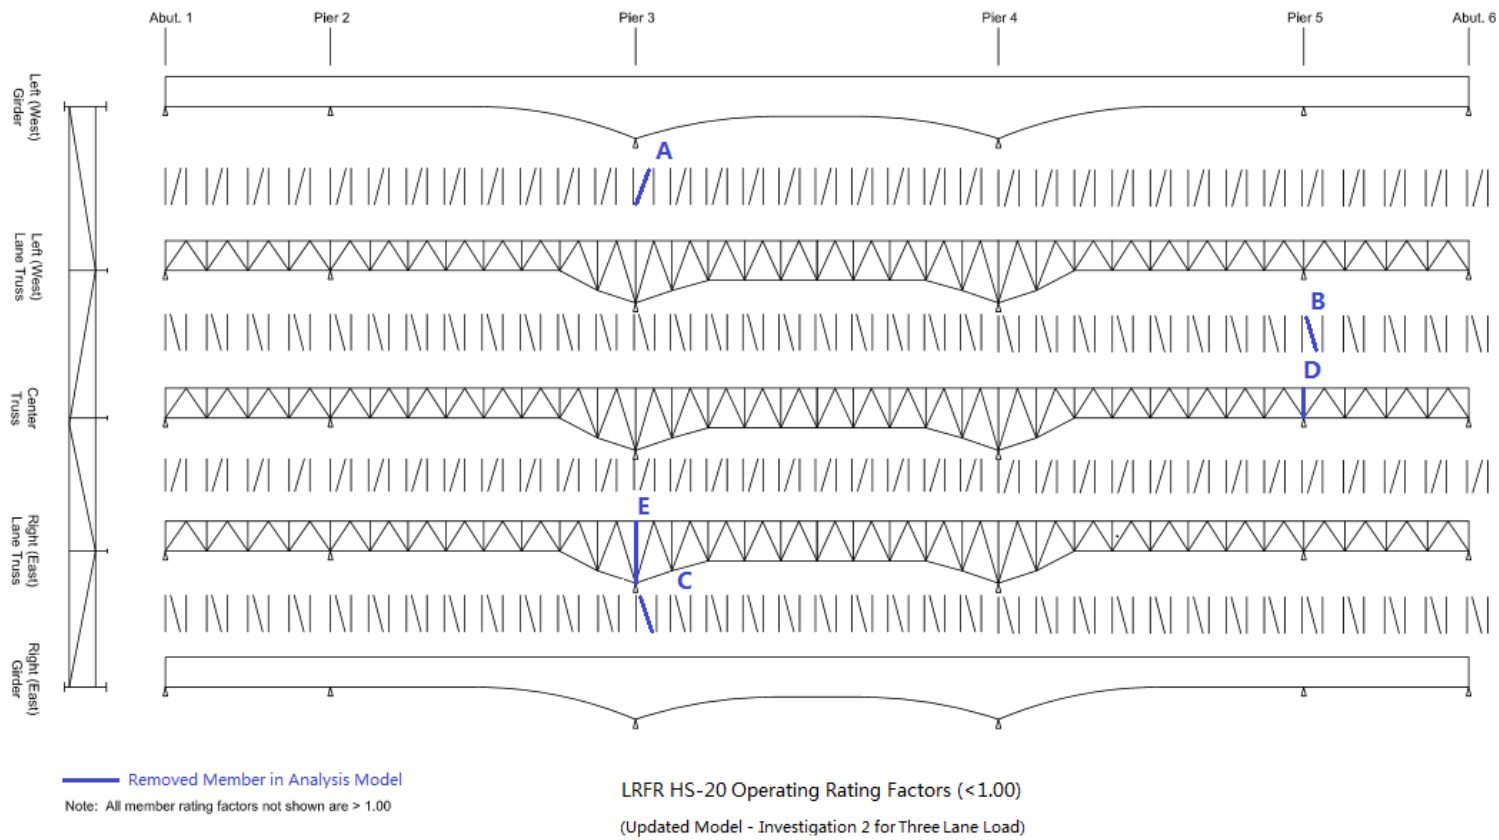
- HS20-44 loads on three traffic lanes: The operating rating passed (see Figure 2.14, Figures 2.23–2.24, and Table 2.3).

Figure 2.14 Operating Load Rating; Three lanes, HS20-44, Model 2 (5 members removed)

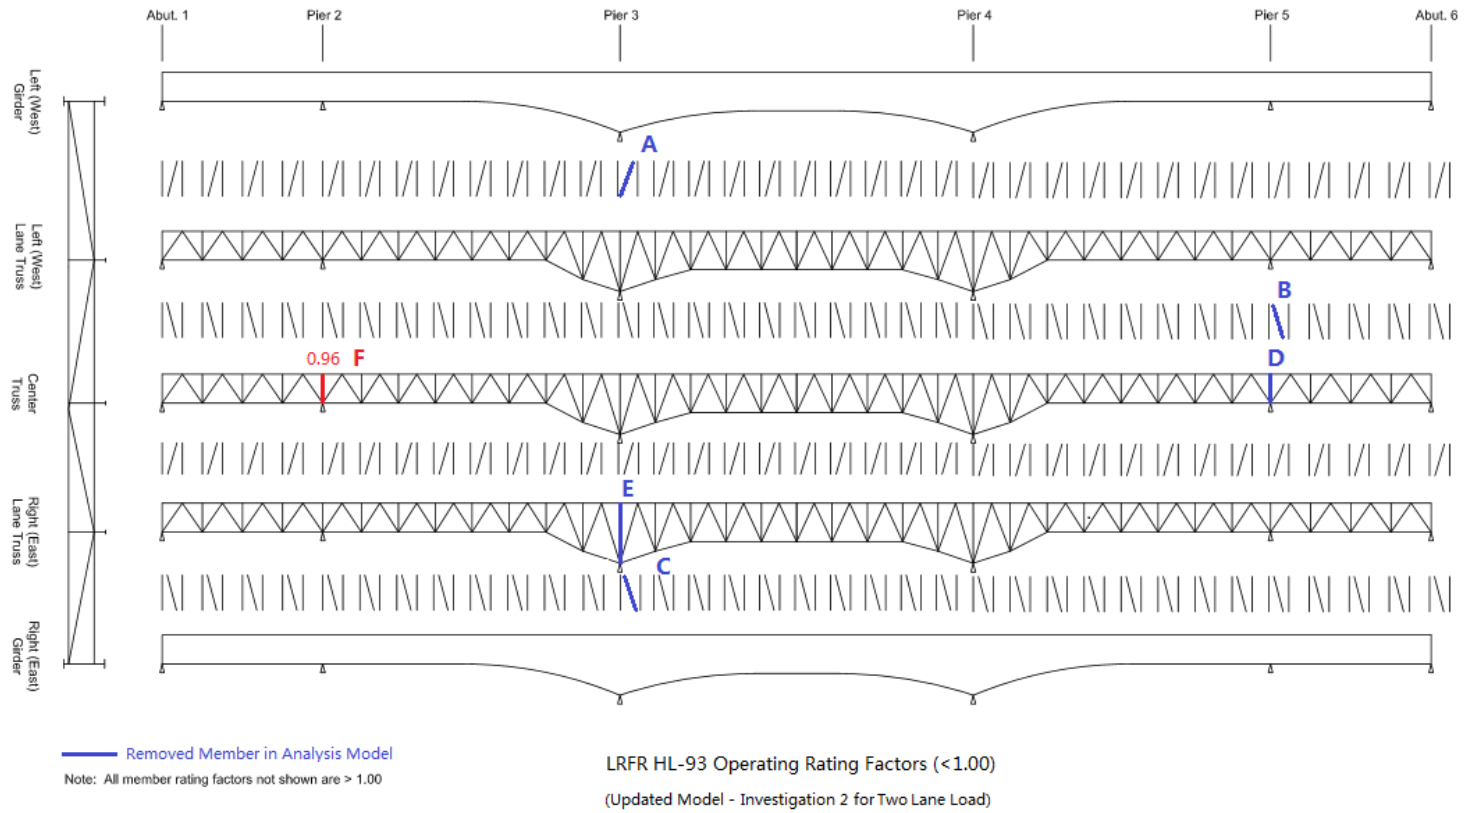
- HL-93 on two traffic lanes: Secondary member (F) had a rating of less than 1 (see Figure 2.15, Figures 2.22–2.24, and Table 2.3).

Figure 2.15 Two lanes loaded, HL-93, Model 2 (5 members removed), RF<1

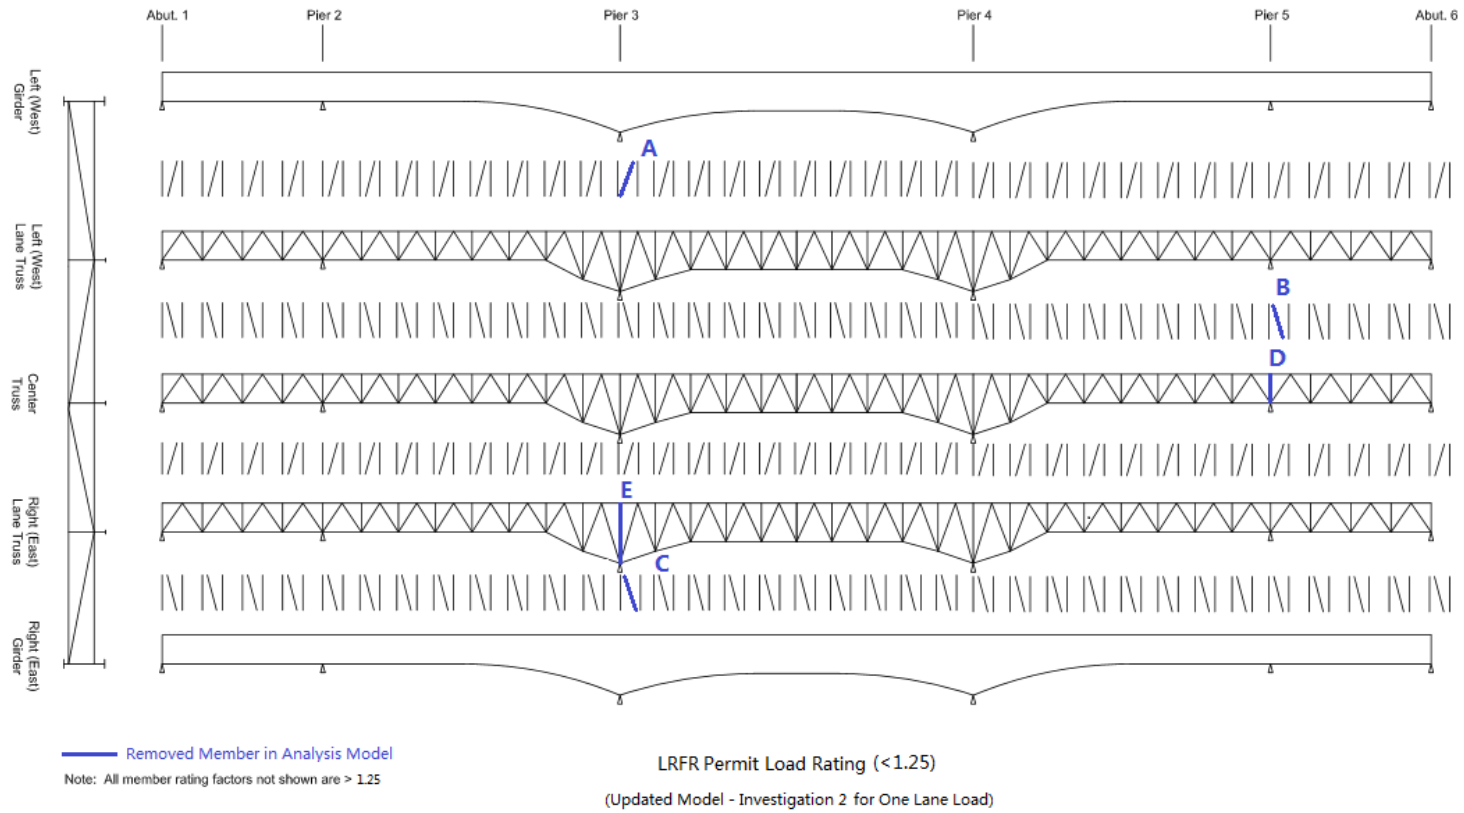
- The bridge was analyzed using Model 2 (five removed members, A–E) for permit loading on one lane (truck on the centerline of the bridge) (see Figure 2.18, Figures 2.23–2.24, and Tables 2.2 and 2.4).

Figure 2.18 One lane, permit load, Model 2 (5 members removed) results $1 \leq RF < 1.25$

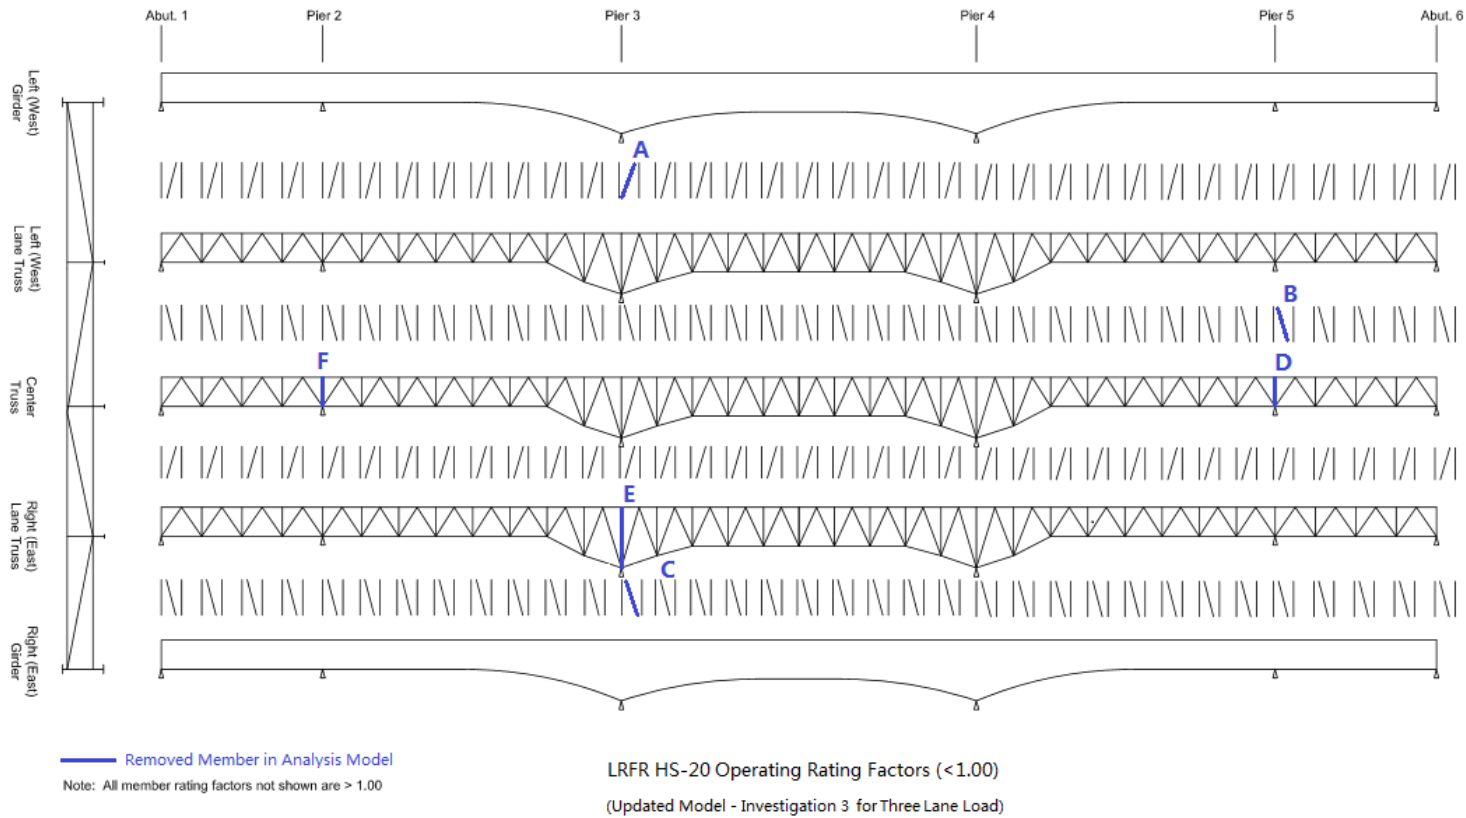
- The bridge was analyzed for an AASHTO HS20-44 load on three lanes of traffic using Model 3 (six members removed, A-F).   The load rating passed (see Figure 2.20, Figures 2.22-2.24, and Table 2.4).

Figure 2.20 Three lanes, AASHTO 20-44, Model 3 (6 members removed), load rating passed

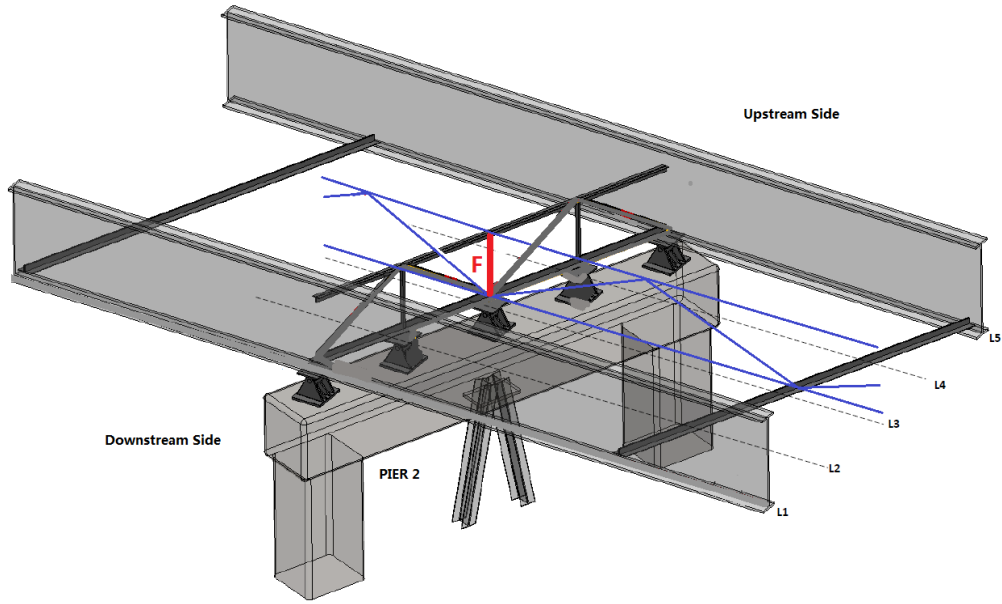
Figure 2.22 Three-dimensional view of secondary member F

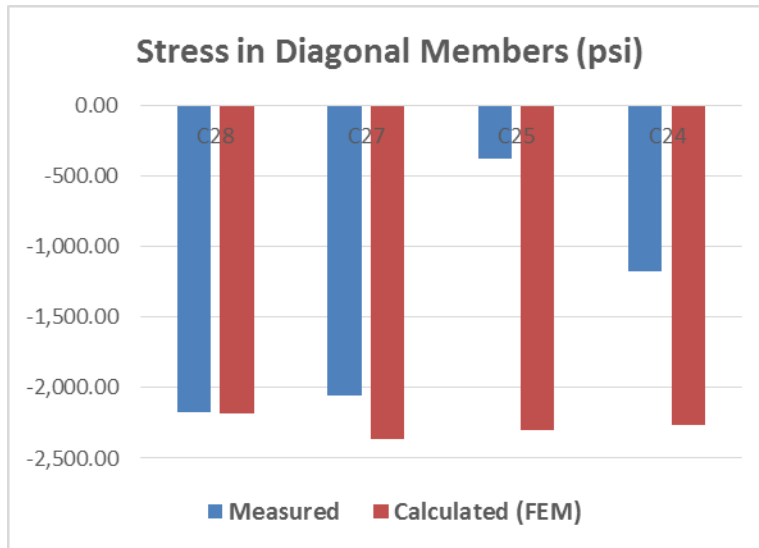
Location	C28	C27	C25	C24
Measured Stress (psi)	-2,171	-2,058	-376	-1,172
HDR FEM Stress (psi)	-2,184	-2,366	-2,305	-2,261
Error (%)	-0.6	-15.0	-512.3	-92.9

Figure D.3 Two trucks at Pier 5 stress results before transverse updating

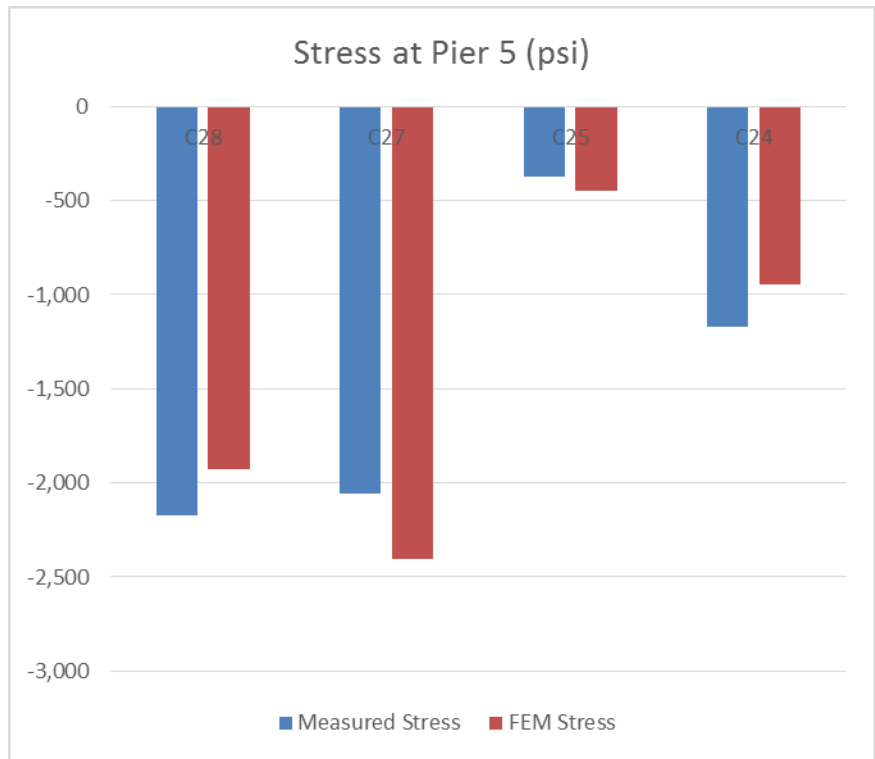
Figure E.2 Two trucks at Pier 5 stress results after model modifications

Following modification of the model, the largest error in the transverse direction decreased from -512.3% to -19.9%. Initially, five support bearings did not support the bridge (i.e., the superstructure was not in contact with the bearings). After the model was modified, bridge response was simulated with two bearings (Bearings 2 and 4) that were not in contact with the structure. At the other three bearing locations, the superstructure is modeled with vertical springs between the bearing support and the structure. The cross frames were found to be too stiff compared with the as-is condition (Xiao, Hulsey and Chen, 2015).
